Technological accidents caused by floods: The case of the Saga prefecture oil spill, Japan 2019

ABSTRACT

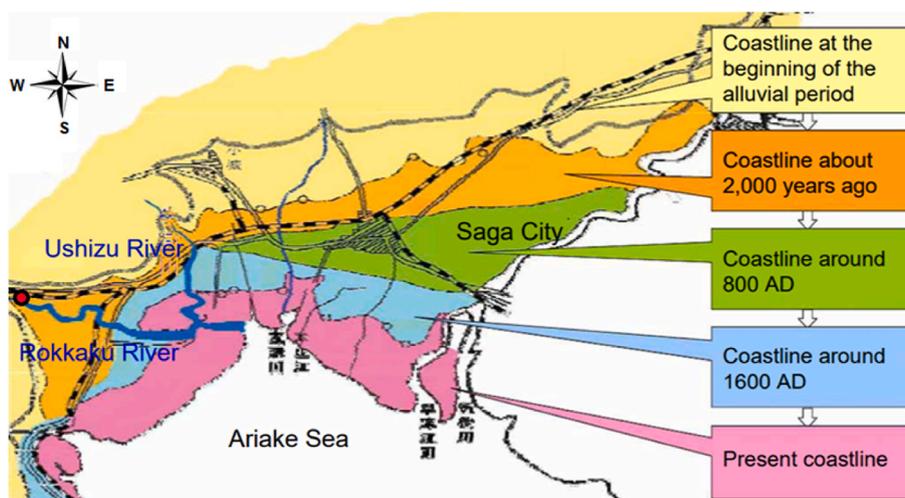
Fig. 1. Coastline of the Saga low flatland area. The source of oil spill is indicated in red. Adapted from Ref. [36].

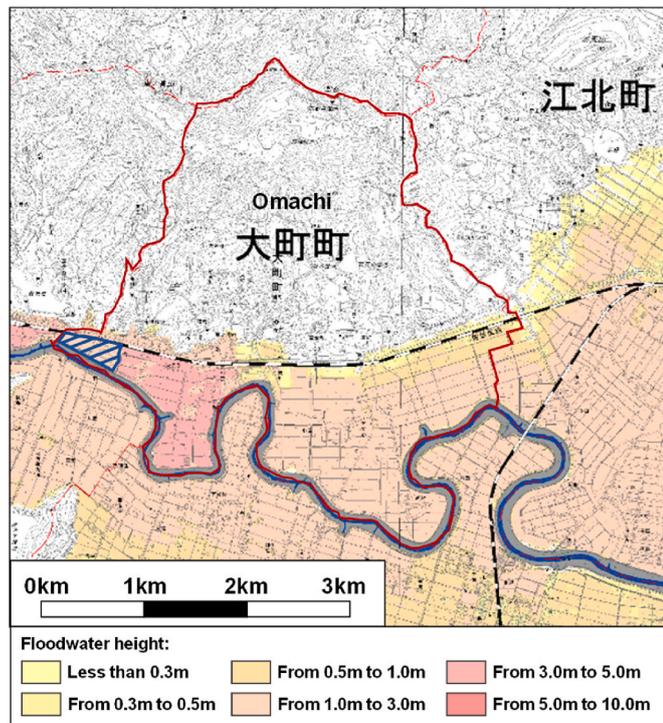
Fig. 2. Flood hazard map for Omachi town area. The blue-dashed area indicates the position of the ironworks factory. Floodwater height is estimated considering the worst-case rainfall scenario of 424 mm (6-h period) [44].

now publicly available for consultation [44]. Fig. 2 reports the hazard map created by MLIT considering the worst-case scenario of inundation caused by the Rokkaku river water system. The rainfall scenario considered is of 424 mm in 6-h period [44]. As can be seen, the southern part of the municipality is exposed to relevant flood hazard, and water height might reach up to 5 m [44]. The worst-case scenario approach is included in flood control evaluations since 2015, and the maximum rainfall scenario to be considered in simulations depends on the region in Japan considered and on the extent of the catching area of the river system [45]. It should be noted that the return period for this scenario is not provided, although in case the estimate results in a significantly lower rainfall severity compared to a 0.1% exceedance probability scenario, the severity of the latter is suggested to be assumed. Therefore, the flood hazard map reported in Fig. 2 can be conservatively associated to a return period of 1000 y [45].

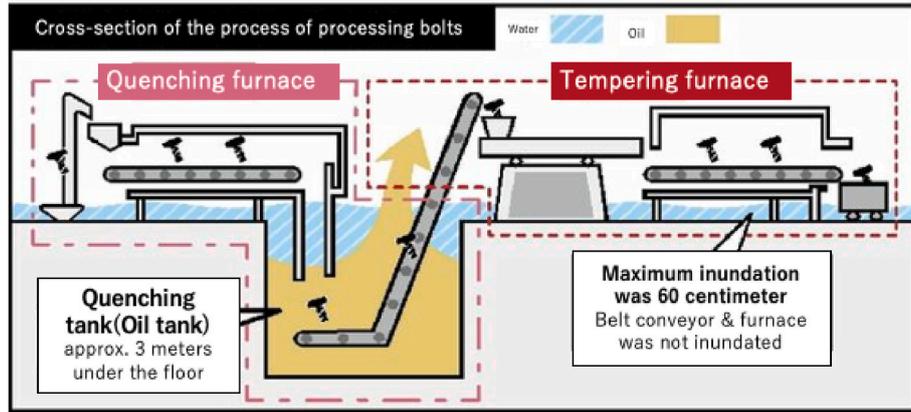
Fig. 3. Simplified scheme explaining the dynamics of oil spill caused by flood. Adapted from Ref. [52].

[52]. Quenching is one of the typical processes performed in metalworks to obtain specific mechanical characteristics and consists of the rapid cooling of heated pieces through large volumes of oil, water, or air [50, 53,54]. One of the typical equipment design solutions for heat treatment of small parts as bolts is a furnace which is directly connected to quench tanks located below the conveyor level that the parts reach directly through a chute [55,56].

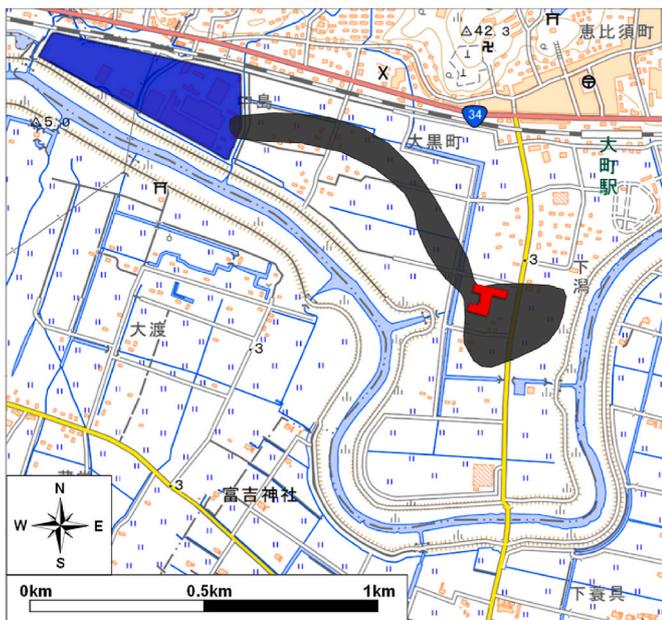
Fig. 4. Approximate path of the released oil. The blue area indicates the ironworks factory, while the hospital impacted is indicated in red. Map adapted from Geospatial Information Authority of Japan website (gsi.go.jp). Oil path realized according to MLIT documentation [43].

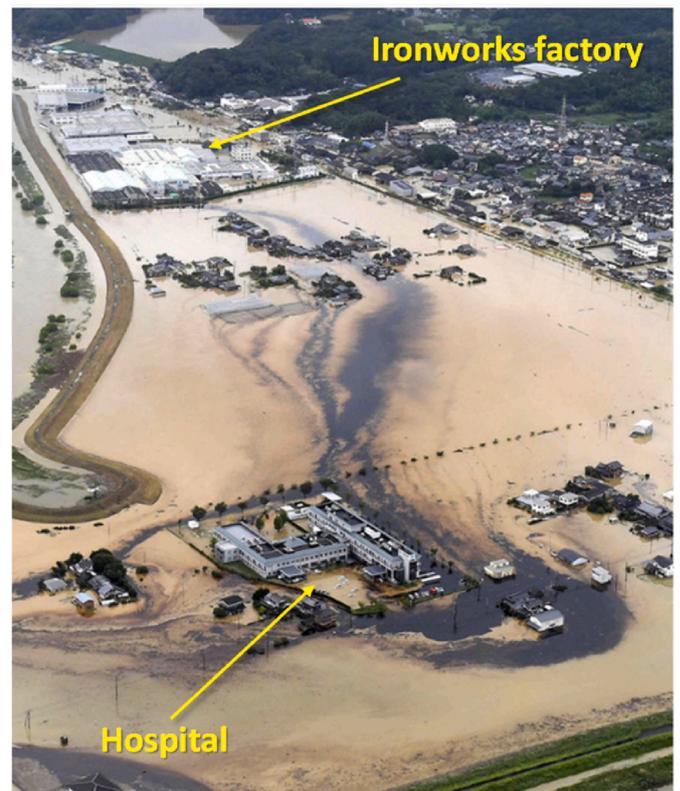
Fig. 5. Aerial view of the area impacted by the oil spill. Adapted from: <http://usagi-syufuulife.com/2019/08/31/2285>.

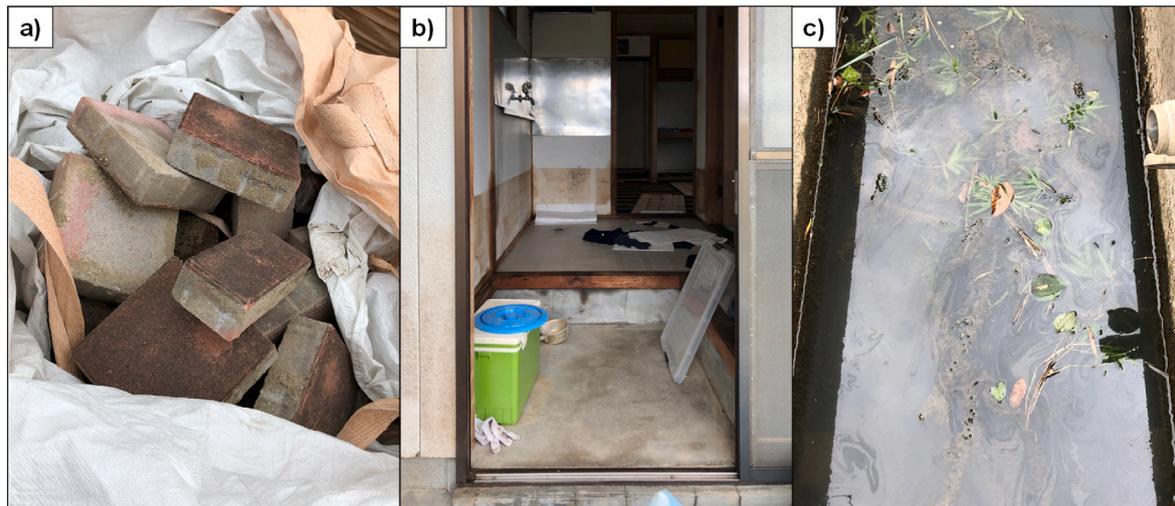
During the first field trip, even if it was carried out about a month after the disaster (late September 2019) the smell of oil was still strong in all the area, and there was evidence of the presence of residual oil in the crop fields and in the damaged dwellings. For instance, it was possible to notice that the bricks of the outside pavement near the entrance of the hospital had been substituted and the old ones, piled in flexible bulk containers, were tainted of oil (see Fig. 6-a), while clear oil traces were identified also on dwelling internal walls (see Fig. 6-b) and in inland irrigation channels (see Fig. 6-c).

Fig. 6. Traces of oil identified during the first field trip in Omachi about one month after the oil spill (late September 2019). a) Old bricks tainted of oil removed from the entrance area of the hospital; b) view of the interior walls of a damaged dwelling which absorbed the oil floating over floodwaters; c) oil sheen in an irrigation canal located between the rice fields.

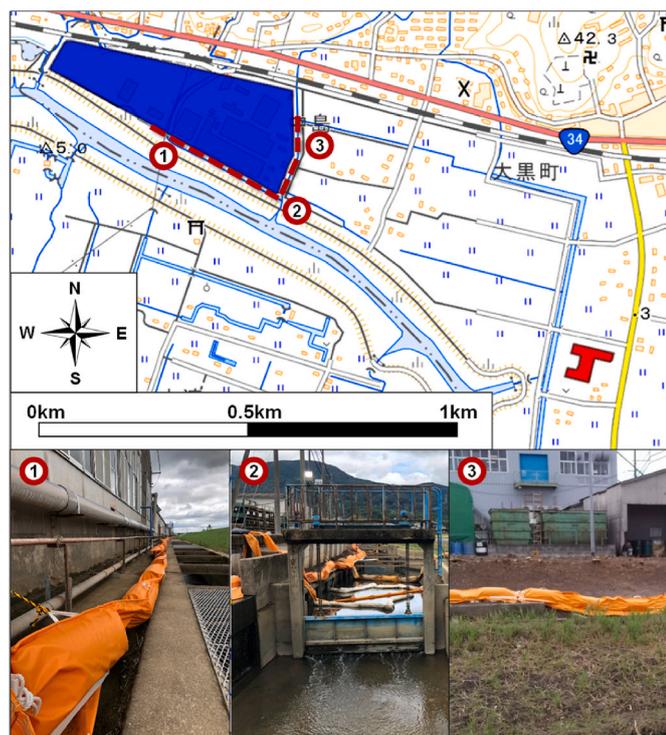
Fig. 7. Permanent oil booms implemented in the east and south sides of ironworks plant premises (in blue), in the closest areas to Rokkaku river embankment (indicated as red dashed lines). Map adapted from Geospatial Information Authority of Japan website (gsi.go.jp). The pictures of the oil booms were taken during the September 2019 field trip.

It should be noted that the same ironworks factory was involved in an analogous oil spill during floods in 1990 [61]. After that accident, the heat treatment building was retrofitted with a series of measures. Heavy shutters had been installed and the floor level of the building where the heat treatment is performed was raised by tens of centimetres to reduce the risk of water entering the oil tanks in case of future severe flooding [52]. According to the available information, the oil spill prevention measures were implemented considering the features of the flood of 1990 [52], and the August 2019 flooding was a far more severe event, whose intensity was not foreseen by company managers and made all these measures ineffective.

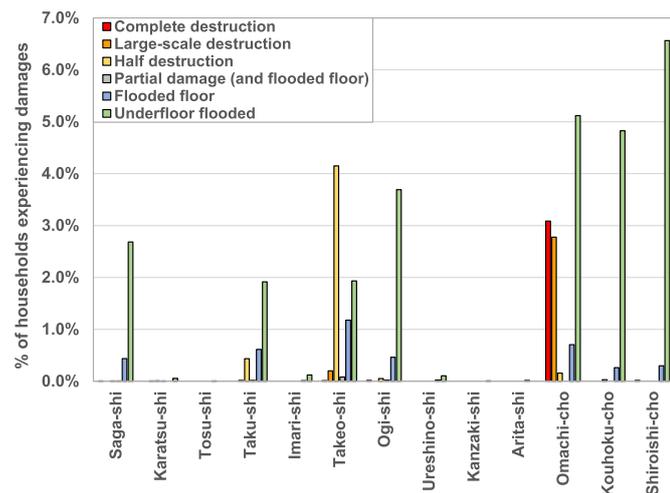
Fig. 8. Percentage of households per city/town experiencing residential damages as consequence of the rainfall event considering the six severity categories reported by Japanese authorities [73].

Results in terms of percentage of households experiencing damages, assuming each household corresponds to a single dwelling are reported in Fig. 8. As can be noted, the highest percentages for the two most severe damage categories (i.e., complete and large-scale destruction) are experienced in Omachi town, where the oil spill happened. This can be possibly attributed to the additional contribution of the Natech event to the already severe impact of floodwaters on dwellings. It should be noted that this information substantially confirms what the NGO local manager declared during the interview, that is, that the oil caused long-lasting damages to houses in addition to the impact of floodwater.
